INSTRUCTION SHEET FOR #2456-1, 2457-1, & 2458-1

POWERGLIDE™ TAPPET, STANDARD O.D. IS .8425"

BIG TWIN SINGLE CAM - FITS 1984-PRESENT

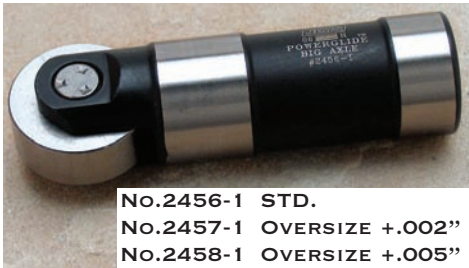
No.2456-1 STD.
No.2457-1 OVERSIZE +.002"
No.2458-1 OVERSIZE +.005"

- THE FIRST AREA OF CONCERN IS THAT THE TAPPET ROLLER MUST SEAT FLAT ON CAM. JIMS® TAPPETS ARE SQUARE FROM THE TAPPET BODY TO THE AXLE BORE WITHIN .0002". IF THE ROLLER IS NOT SEATED FLAT ON THE CAM, IT WILL FAIL WITHIN A SHORT PERIOD OF TIME.**
