## Congratulations

# FOUR POSSIBLE REASONS THAT MAY KEEP NEW HYDRAULIC UNITS FROM WORKING PROPERLY

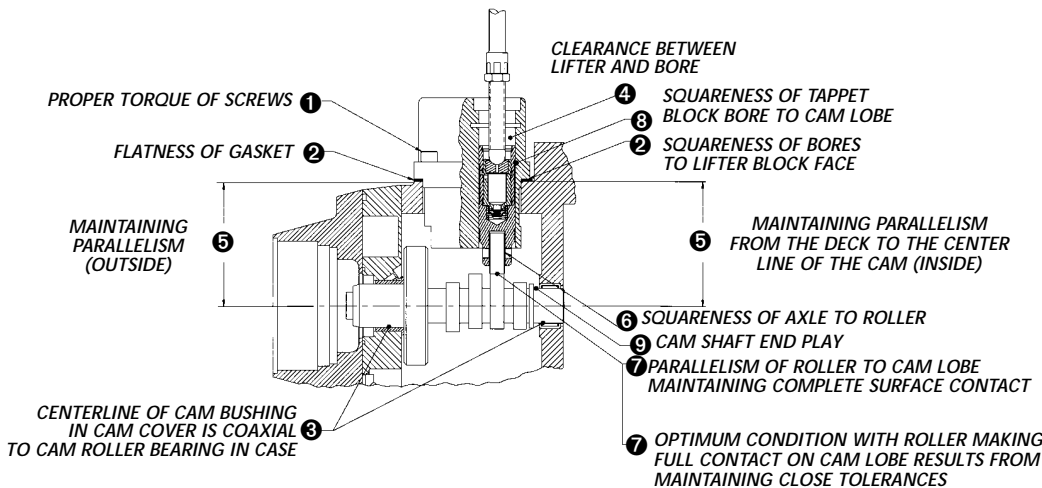
Pushrod Adjustments				
Distance per turn	Distance per flat	Threads per inch	Wrench Flats	Total Travel Distance
.0417	.0069	24	15	.1042"
.0357	.0059	28	17	.1011"
.0313	.0052	32	18	.0937"
.025	.0042	40	24	.100"
.0192	.0032	52	30	.0962"

- To isolate a possible noisy hydraulic lifter start with a cool motor and the lifter you think is making the noise. With that lifter on the heel of cam, valve shut, adjust pushrod so lifter unit is all the way compressed down ( very important ) this adjustment will make the pushrod tight which will bleed down the hydraulic lifter. It will sometimes take (5) five minutes, or longer, to bleed down. Do not rotate engine while pushrods are tight. Go to the point where pushrod will spin with your fingers. Adjust down a little more until pushrod becomes tight ( you can just barely turn with your fingers ). Start bike, if it is quiet then you have found the lifter that was not working properly. If it's still noisy continue with the next lifter until you have located the the noisy one. Readjust per instruction sheet, or replace lifter.
