Instruction Sheet For Part #2369 & #2404

PUSHROD ADJUSTMENT

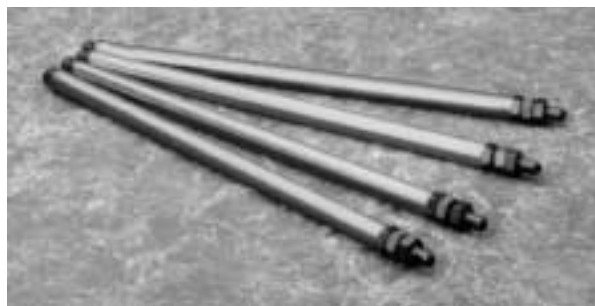
Threads Per Inch	Wrench Flats	Total Travel	Distance Per Turn	Distance Per Fl at
32	18	.0937	.0313	.0052

3. If you are using these pushrods for JIMS® Tappets #18522-53PG or 2459-1, follow the adjustment instructions using the 32 threads per inch adjustment.

4. If you are using these pushrods for JIMS® Tappet Block Kit #1029-53B, follow the adjustment instruction also using 32 threads per inch adjustment.
NOTE: This adjustment will make the pushrod tight which will bleed the hydraulic lifter. It can take 5-15 minutes, or longer to bleed off. It is very important that the engine is not rotated while pushrods are tight. The pushrod will spin with your fingers after the tappet has bled off.
